NSROC Technical Summary

Cruddace/36.162 Mission Failure

Wilkinson/36.183 Mission Failure

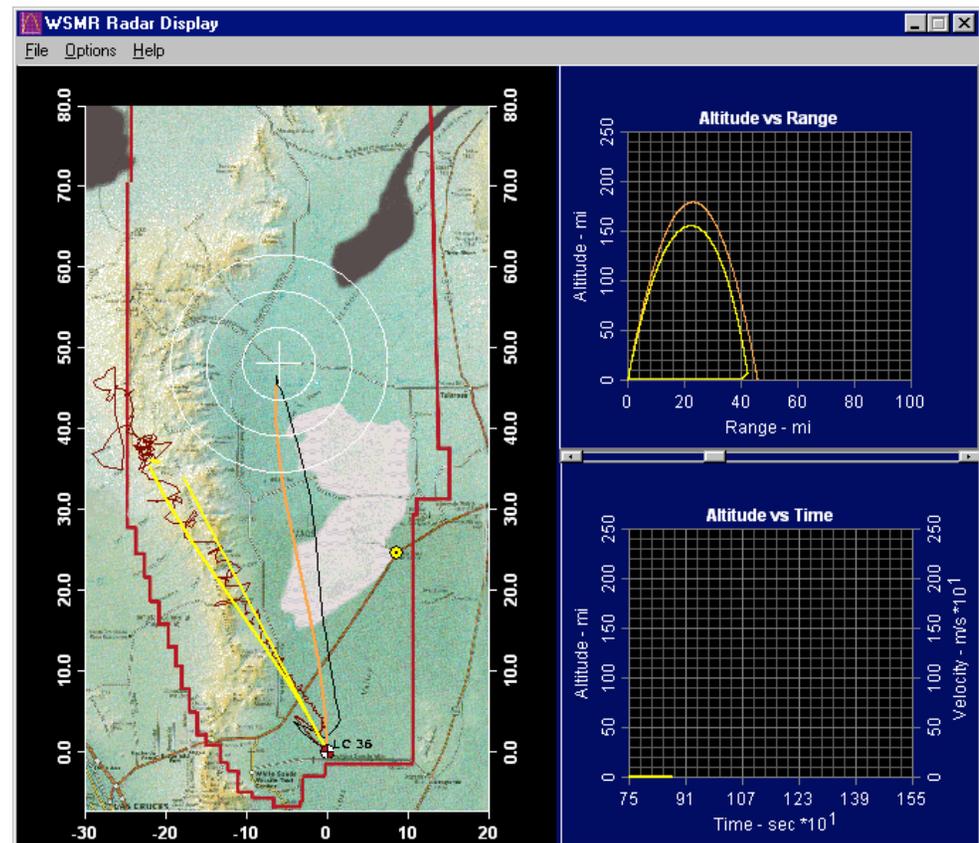
- The launcher settings were based on a wind profile that was over 65 minutes latent on a dynamic night. The jet stream shifted at $\approx t - 20$ minutes, from directly above the launcher towards the range center, resulting in an $\approx 25\%$ drop in the overall wind profile. The composite wind profile was the highest noted for a sounding rocket mission at WSMR (~ 30 knots from surface to 40kft.)
- The NSROC prelaunch process did not fully analyze the wind data as accomplished pre-1997.

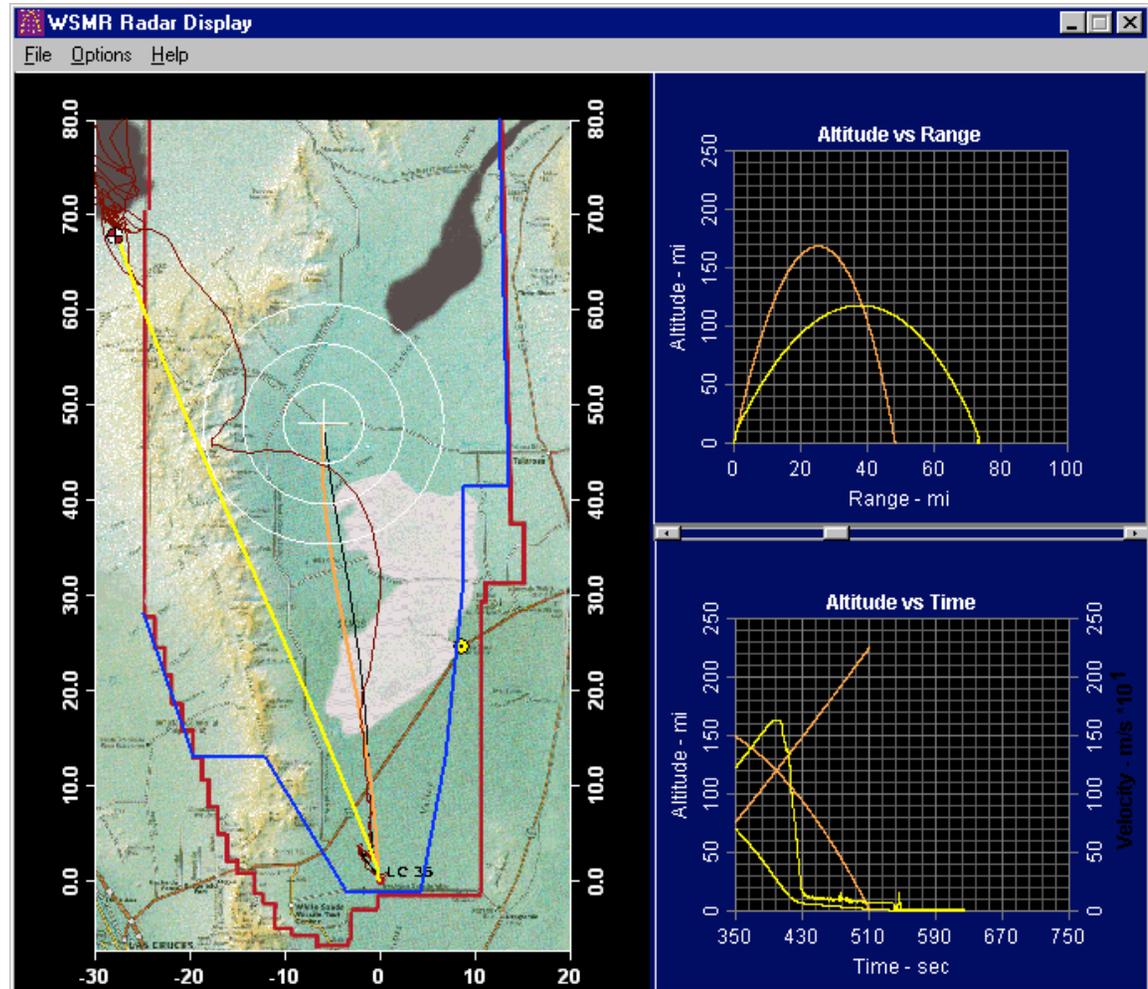
- On Friday evening, May 5, 2000 at 2330 local (WSMR), the Wilkinson/36.183 vehicle was launched.
- At $t + 28.79$ seconds, the vehicle deviated from the predicted flight path.
- At $t + 39.9$ seconds, WSMR Flight Safety implemented the Thrust Termination event.
- An AIB was established on May 6, 2000 in the wake of the mission failure.

- Two significant anomalies were noted:
 - DS-19 Boost Guidance System (BGS)
 - Known is the DS-19 calculated IIP deviated from the nominal flight path, based upon DMARS sensor anomalous input at 27.89 seconds.
 - Indications now relate to solder drop on the yaw gyro calibration lead. The cal input shorted during the sustainer burn and the yaw gyro IIP output deviated by 15 deg.
 - Recovery System
 - The recovery system failed and the payload was recovered with extensive damage.
 - Failure identified to the parachute package. AIB still investigating the specific cause.
- The Failure Investigation is open and ongoing.
