40.017 UE/Lynch Sounding Rocket Mishap Investigation Board Briefing to SRWG

January 20, 2006

Mishap Overview

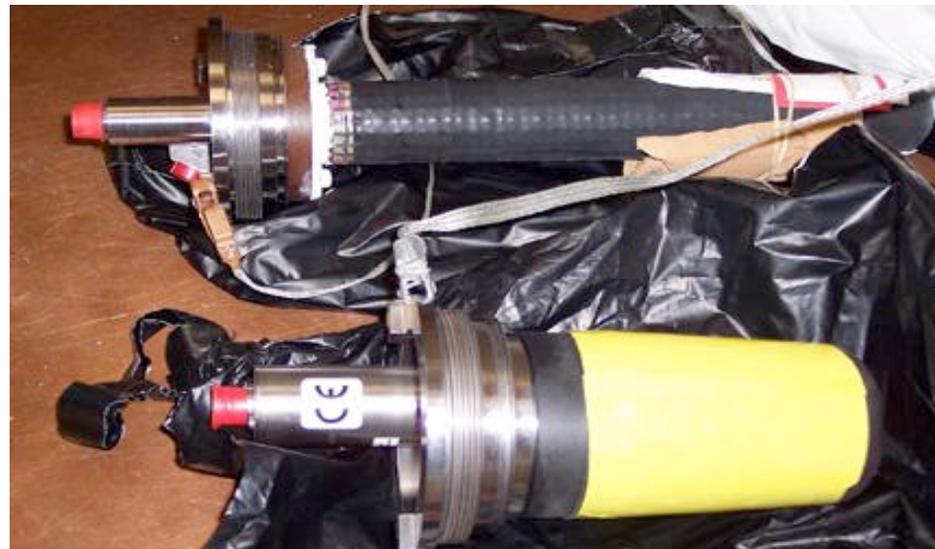
Proximate Cause: (event that occurred)

- Failure to ignite motor due to inadequate thermodynamic performance of igniter. (Charge size, geometry) OR
- Failure to ignite motor due to structural failure of igniter basket under ignition loads.
